# SERVICE INFORMATION

## STANDARD AND TRIUMPH VEHICLES

<b>No.</b>	SPORTS/10/N	FITTING OF LISTING RODS	<b>Date</b>	JULY 1957
------------	-------------	-------------------------	-------------	-----------

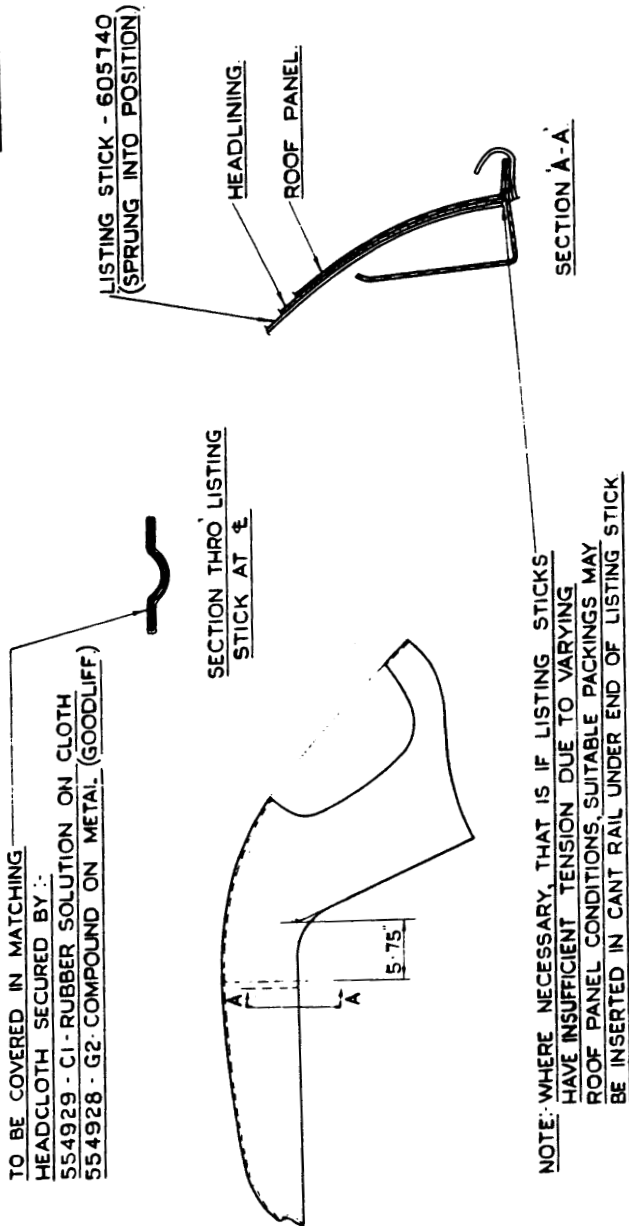
DESCRIPTION	MODEL
FITTING OF LISTING STICK	TR. III

In order to prevent the headlining "festooning" when the adhesive fails after a period of service and to obviate the necessity for removing and refining the trim a service scheme for the introduction of a listing stick has been prepared.

The listing stick should be covered with the same material as the headlining and although fitted on the underside of the lining and visible is in no way unsightly.

The listing stick should be fitted as explained in the illustration and the necessary items can be obtained from our Spares Division as per the following details:

TO BE COVERED IN MATCHING HEADCLOTH SECURED BY :  
554929 - C1 - RUBBER SOLUTION ON CLOTH  
554928 - G2 - COMPOUND ON METAL (GOODLIFF)
