LEYLAND-TRIUMPH SALES COMPANY, INC.

WESTERN ZONE

TO: ALL TRIUMPH DEALERS - WESTERN ZONE

DEPT: SERVICE DEPARTMENT

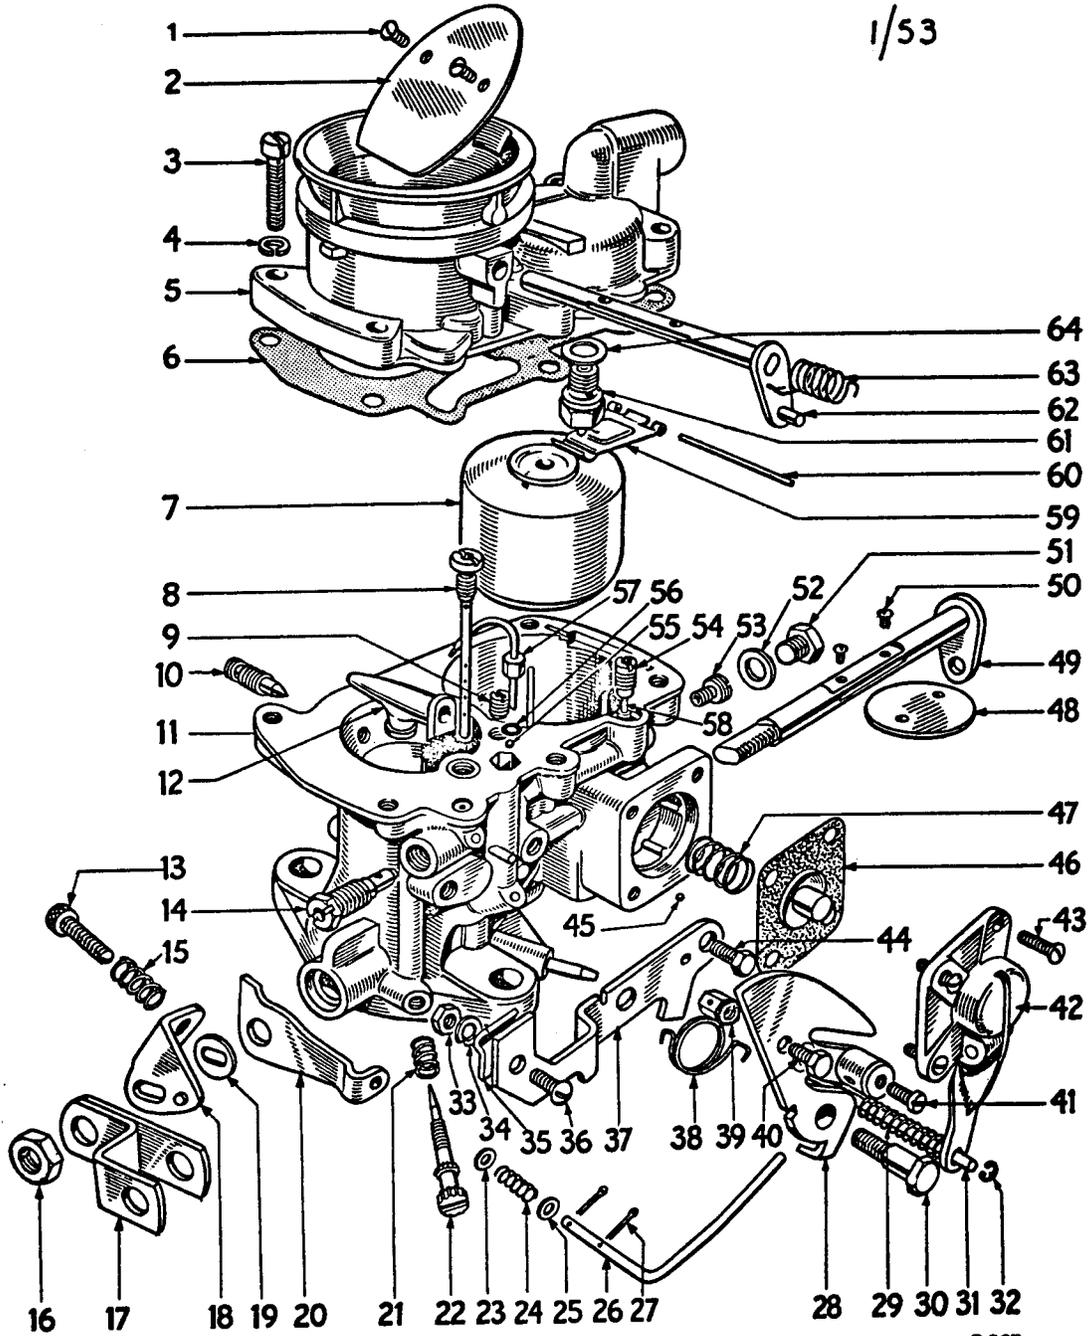
Exploded view of Solex B.30 P.S.E.I. Carburettor

if the accelerator pump jet (57) is removed as suggested in paragraph "C," extreme care must be taken to ensure that the non-return ball (55) situated under the nozzle is not ejected. This may occur if compressed air is used for cleaning the float chamber or if the butterfly or pump levers are operated. The ball can then drop into the carburetor intake and be drawn into the combustion chamber.

NOTE: When replacing the top cover (5), the strangler (2) must be held open, otherwise, by the neutral spring action, it will close and then be on the wrong side of the strangler operating cam (28).

- (a) Remove top cover (5) (5 screws).
- (b) Remove float lever (59) and float (7).
- (c) At this point the accelerator pump jet (57) will loosen and could be knocked into the throat of the carburetor. Therefore, it is advisable to remove it, being careful not to lose the neoprene sealing washer (56) on the underside of the nozzle.
- (d) Remove plug (51) at lower front side of the float chamber and insert screwdriver to remove main jet (53), which is on the inside face of the float chamber.

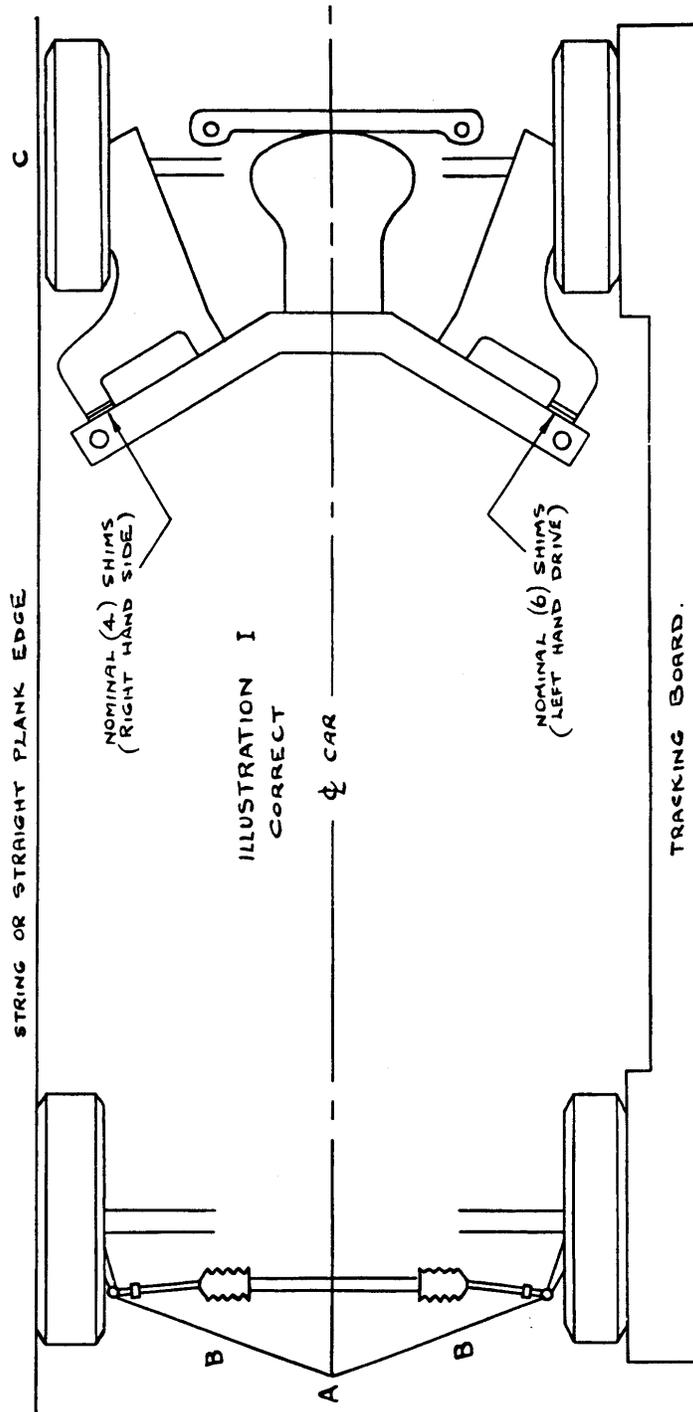
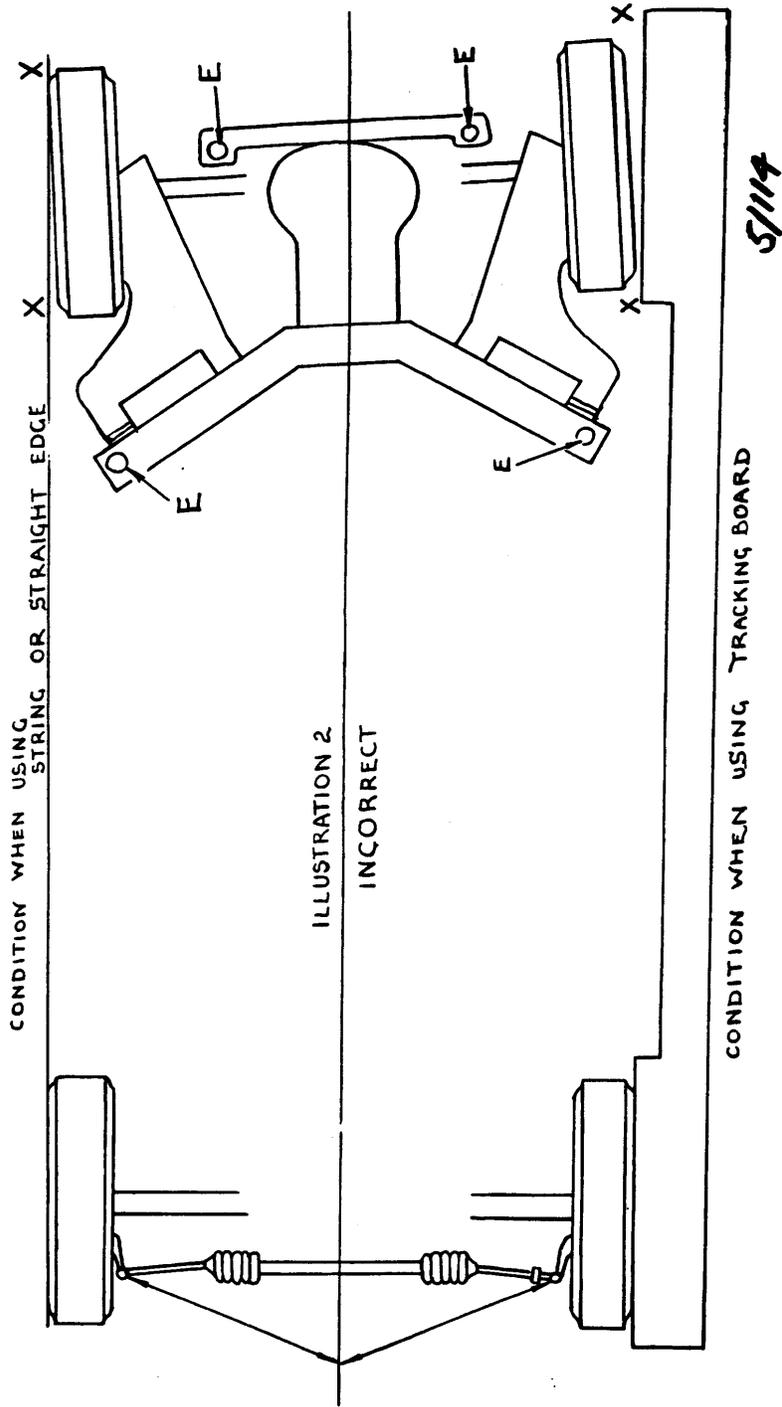
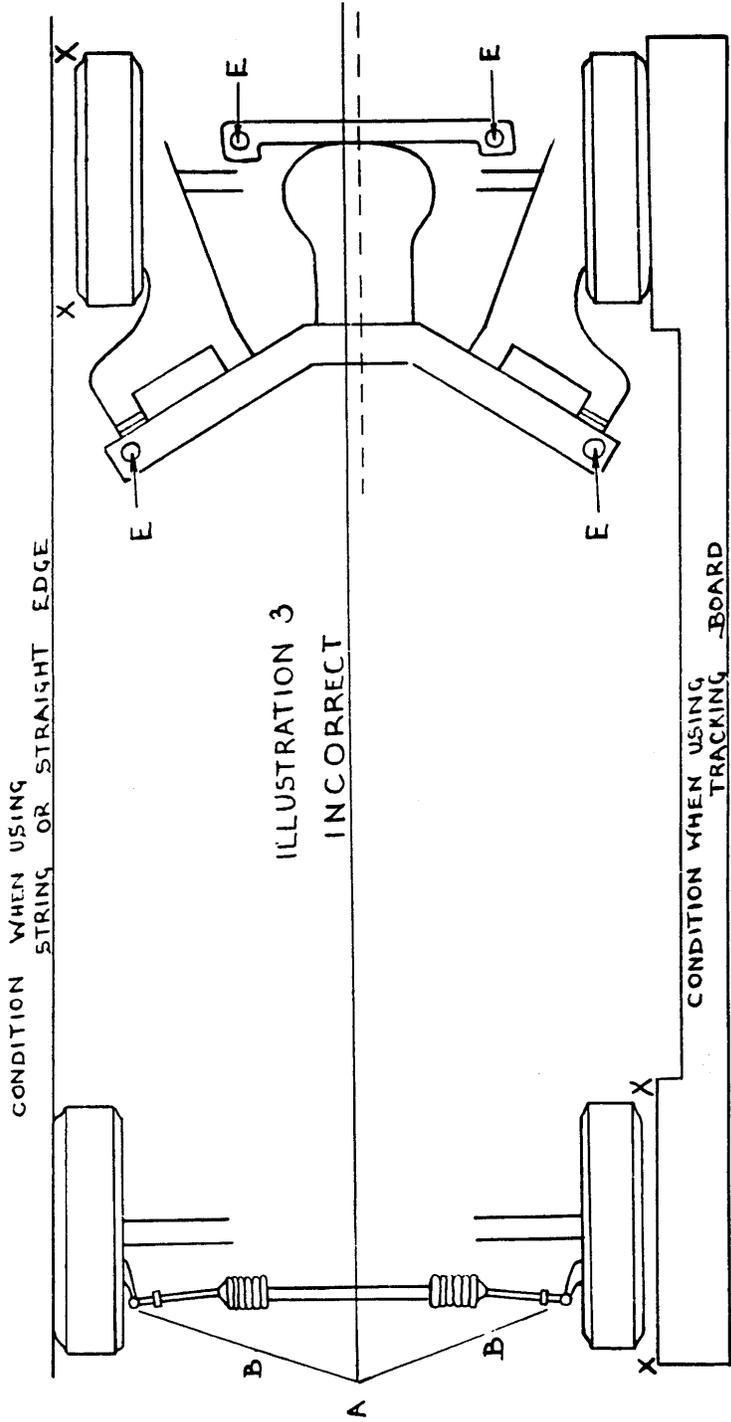
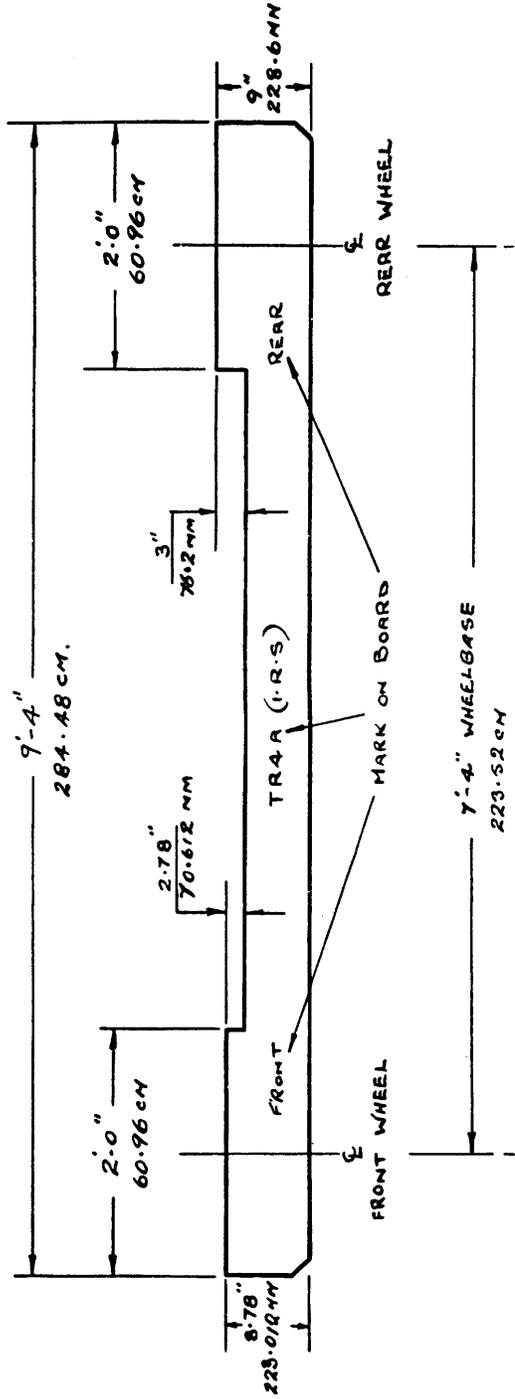
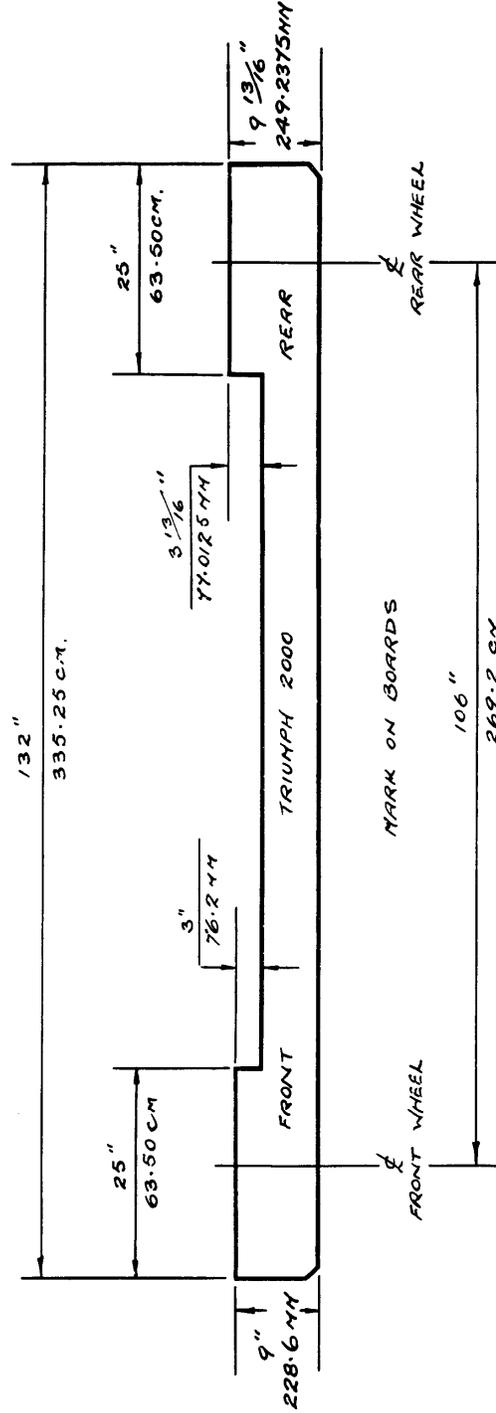
When investigating complaints of excessive tire wear and/or alleged crabbing on the above models, the rear wheel alignment, i.e., the front to rear tracking may be carried out without recourse to expensive special equipment by adopting the following procedure. Where specialized equipment may be available the instructions on pages 4.204 through 4.212 would be found useful. (shop manual)

1. Set front wheel track to parallel by adjusting tie rods equal amounts. Slacken off gaiter clips to prevent damage to gaiters when turning tie-rods.
2. Set rear wheel track to parallel by adding or subtracting shims from between trailing arm and cross-member.
3. Place car on a ramp and ensure front wheels are in a true straight-ahead position. This can be achieved by ensuring that the measurement "B" from each outer tie-rod ball joint stem to the center hole "A" in the front cross member are equal. Illustration 1.

When using string or straight edge, half the difference in rear wheel track must be taken into account at point "C" which will be approximately equal at both rear wheels.

5. To allow for possible discrepancy in tire wall truth, 2nd and 3rd straight edge checks should be taken at 120 degree radical points about the tire, which positions should be achieved by rolling the car backwards and forwards from its first check position.
6. If misalignment, as shown exaggerated at points "X" in illustrations 2 and 3 is evident, the four attachment points of the rear sub-frame unit "E" must be slackened off and the sub-frame pivoted or moved sideways about these points until the correct condition is obtained. During this operation, the weight of the car should be taken off the rear suspension by means of jacks under the two rear jacking points on the body.
7. The front and rear wheel track setting may be left in the parallel condition.
