LEYLAND-TRIUMPH SALES COMPANY, INC.

WESTERN ZONE

TO: ALL TRIUMPH DEALERS - WESTERN ZONE

DEPT: SERVICE DEPARTMENT

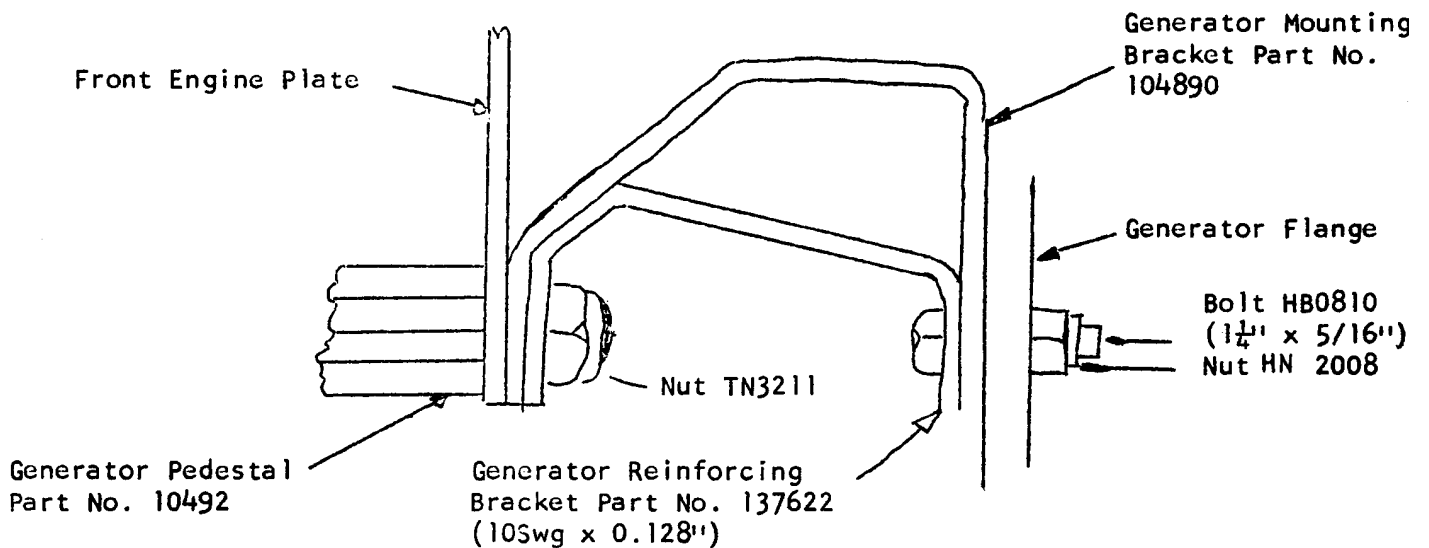
Should a failure of the generator mounting bracket occur on any of the above models, the bracket should be replaced by the following details which include an additional reinforcing bracket.

The diagram shown below illustrates the location of the additional reinforcing bracket.

The reinforced bracket was introduced on production at the following engine numbers: GA-117163-E, GC-9042-E and FC-12035-E.

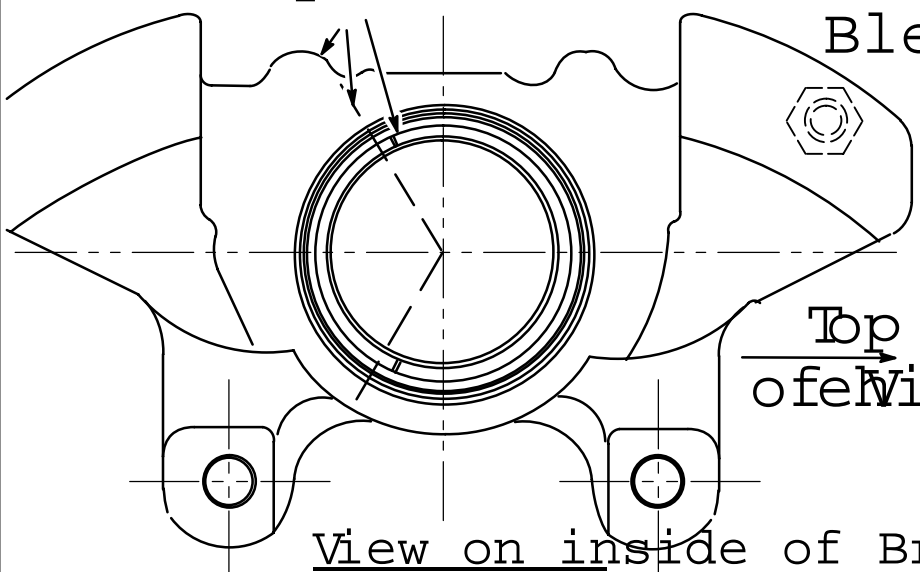
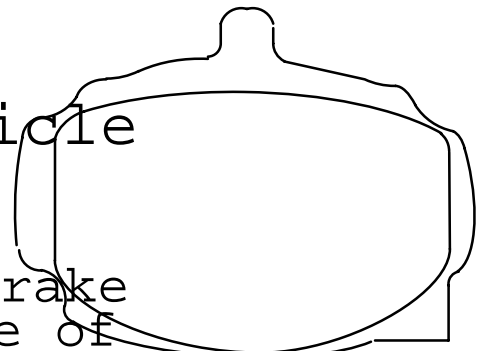
SCHEME SHOWING CALIPER PISTON AND ALSO CORRECT POSITION OF DISC PADS TO OVERCOME SQUEALING.

Piston to be positioned with the step in top position relative to casting as shown

View on inside of Brake Caliper from RH Side of Vehicle

Disc pad to the Inside with the Edge on the Same Side as the Bleed Screw
