TO: ALL TRIUMPH DEALERS - WESTERN ZONE

BULLETIN T-67-1
(Re-issue of T-64-1)

SUBJECT: LAYCOCK OVERDRIVE

BULLETIN T-67-2
(Re-issue of T-64-3)

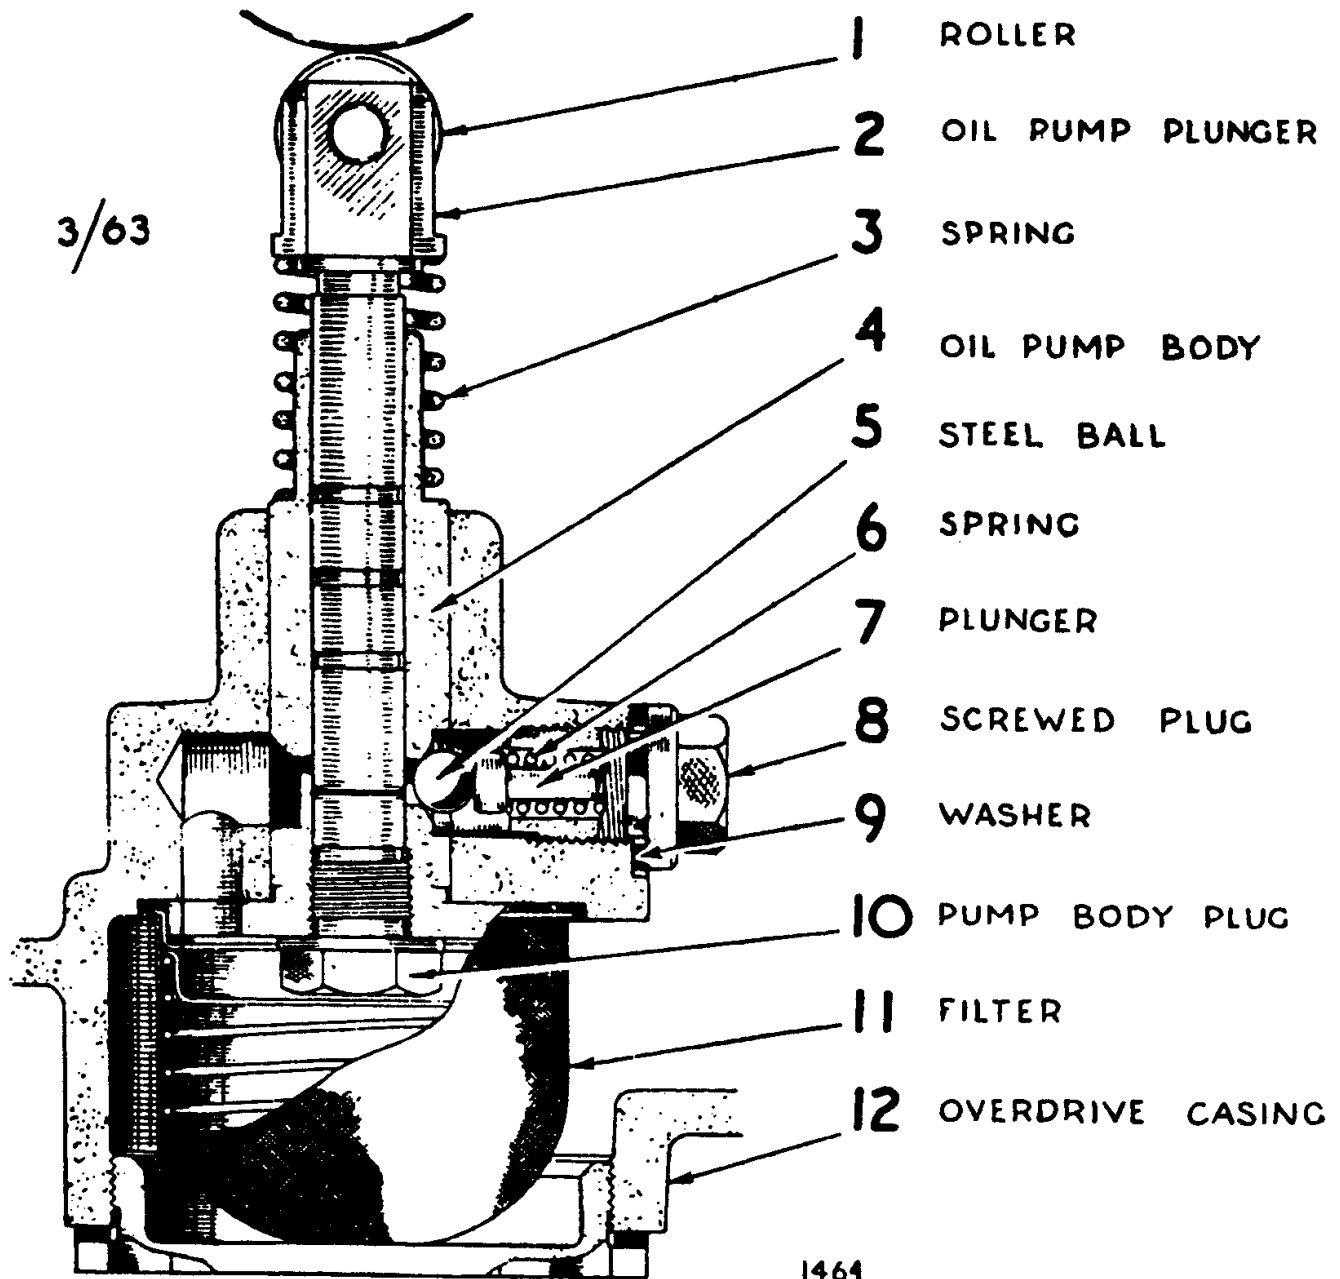
FIG. 1

In "A" type units access to the valve necessitates removal of the solenoid and solenoid bracket. The bracket is secured by two 5/16" (7.937 mm.) diameter studs and two t/16" (7.937 mm.) diameter bolts, the head of the bolts being painted RED. THE NUTS MUST BE REMOVED FROM THE STUDS BEFORE TOUCHING THE BOLTS. The two bolts should not be slackened off together releasing the compression on the accumulator spring which abuts the solenoid bracket.

- 1 ROLLER
- 2 OIL PUMP PLUNGER
- 3 SPRING
- 4 OIL PUMP BODY
- 5 STEEL BALL
- 6 SPRING
- 7 PLUNGER
- 8 SCREWED PLUG
- 9 WASHER
- 10 PUMP BODY PLUG
- 11 FILTER
- 12 OVERDRIVE CASING

PUMP VALVE

After removing the valve plug, spring, plunger and ball, clean the seat and reset the ball by giving it a sharp tap with a suitable hammer and drift.

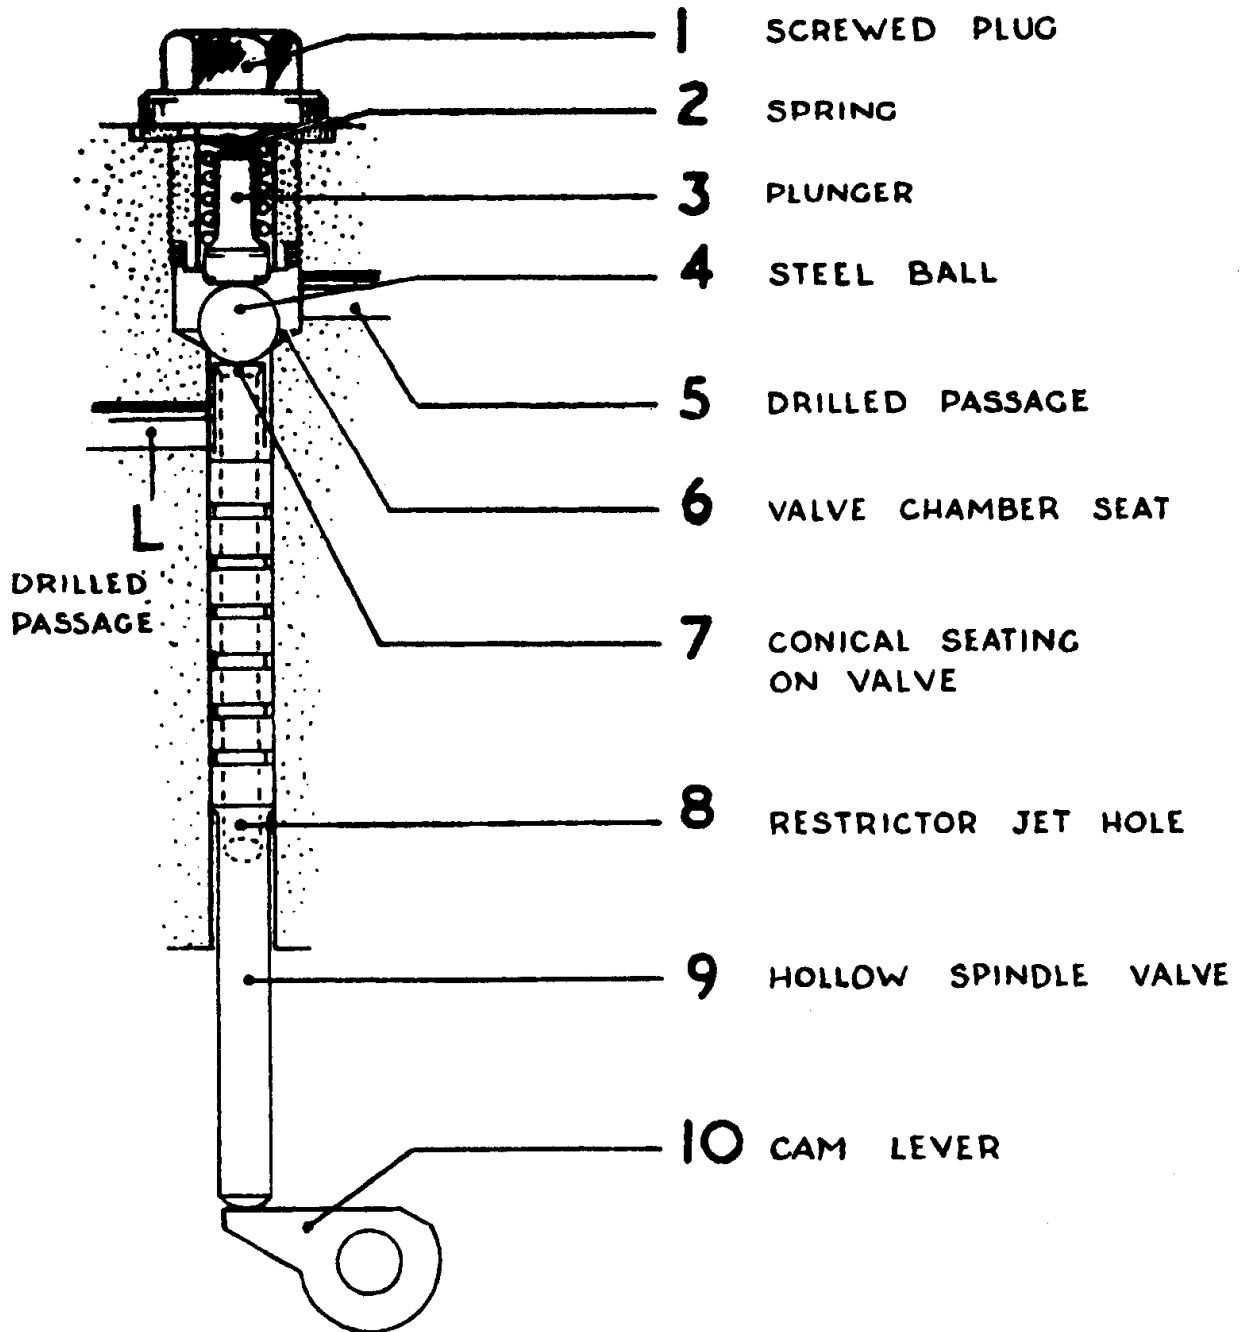
OPERATING VALVE 3/63

The operating valve plug is located on top of the unit. Release hydraulic pressure, unscrew plug and remove spring, plunger and ball. A small magnet will be found useful for this operation. Remove operating valve by inserting a stiff piece of wire and drawing it up. Near the bottom of the valve will be seen a small hole breaking through the center drilling. Ensure that this is not choked (Figure 2).

If necessary, the ball can be reseated on top of the operating valve by placing the ball on a block of wood and sharply tapping the valve after positioning it on the ball. Clean the valve seat in the casing and if necessary reseat the ball by tapping it gently on its seat with a copper drift. Do not tap the ball too hard or the mouth of the hole will be closed up so that the valve cannot be reassembled.

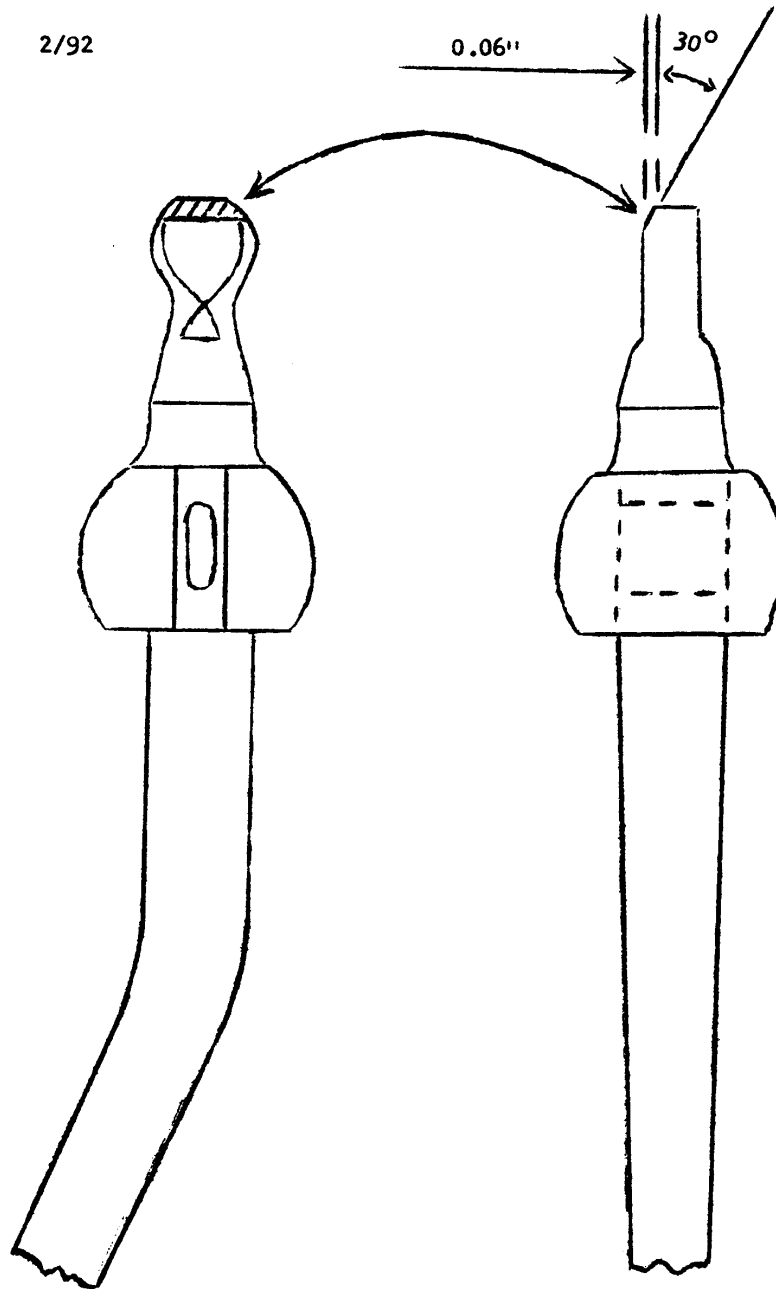
T-67-14

To overcome complaints of gear lever rattle on the TR-4 and TR-4A range of cars, the following modification can be carried out.

The ramp of the modified selector is chamfered off to enable reverse gear to be selected by knocking the lever over, instead of lifting it into position. This is necessary due to the heavy type spring fitted.

- (c) Grind a small 30° chamfer on the side of the ball end of the gear lever adjacent to the reverse selector.. This is necessary to assist the "knock over" action. (See illustration attached)
- (d) Lubricate and assemble all parts, but replace the original gear lever spring with the heavier type, part number 145472. Ensure that the small plunger and spring in the ball end of the lever do not become displaced on assembly.
