# TECHNICAL SERVICE BULLETIN

74-H-1

ANTI-FREEZE

### Safety Recall Campaign A444

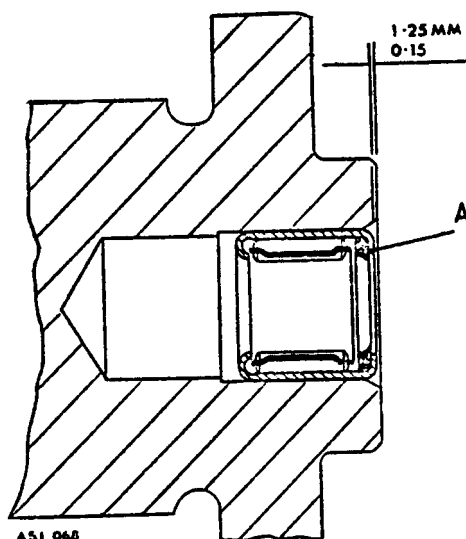
In the event that a TR7 owner should complain of a squealing noise emanating from the spigot bush in the rear of the crankshaft on 1975 and 1976 TR7s, this can be overcome by the installation of a needle roller bearing, part #UKC 8154 in place of the bronze spigot bush. (Refer to diagram).

6. Insert needle roller bearing, part #UKC-8154, with the integral seal A (refer to illustration) facing the gearbox side. The needle roller bearing is to be pressed into the crankshaft to the dimension shown in diagram.

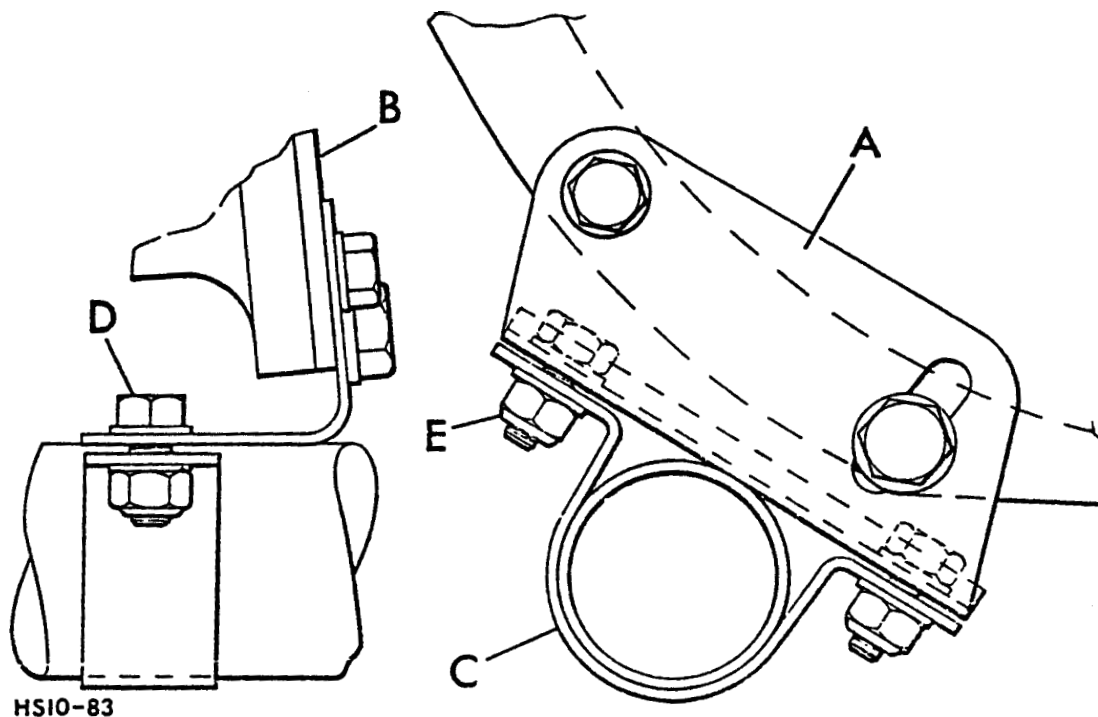
An extra support bracket and clip were introduced on production at VIN #FM-63214. The purpose of this support bracket is to prevent exhaust down pipe and/or exhaust gasket failure.

1. – Detach the support bracket “A” (part #UKC9171) to the forward side of the engine back plate “B” (as illustrated) using the two existing bolts. Do not tighten the bolts at this stage.
2. – Fit the appropriate clip “C” (part #UKC9611 or part #UKC9172) to secure the exhaust pipe to the support bracket.
3. – Tighten the clips securing bolts “D” and “E” (part #HU0806 and #143802).
4. – Tighten the support brackets securing bolts.
