# TECHNICAL SERVICE BULLETIN

74-H-1

ANTI-FREEZE

### Safety Recall Campaign A444

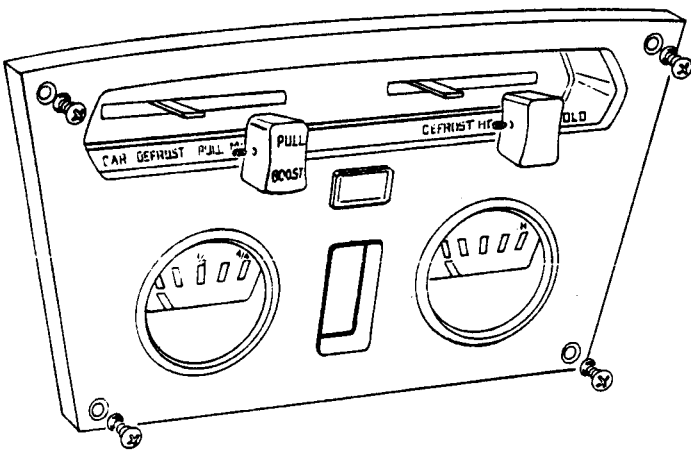
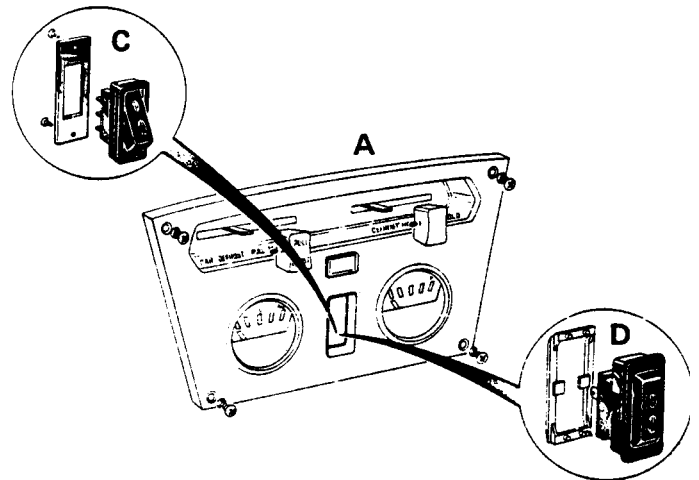
## WOOD DASH – TR6 (ALL)

The possibility exists of malfunction of the headlamp switch which may result in a loss of taillamps, or headlamps and taillamps. Breakage of the switch will only occur when it is actually being turned on or off. It will not, for example, suddenly cease to function while the lamps are in use. Care should be taken when operating the switch as applying excessive force may cause breakage. If you experience a headlamp switch failure, the vehicle should be operated only during daylight hours.

1. Remove battery ground terminal.
2. Remove speedometer.
3. Remove existing switch by depressing clip (see illustration B).
4. Mark position, (or make a note) of the three wires using number reference on switch (1, 2, & 3) before removing each of them from the switch terminals. Push wires inside dash, away from opening (see illustration B).

5. TR6 Headlamp Switch Kit Replacement. Special Cutting Tool BLT-2068. Procedure to cut metal dash backing.
  - A. Separate die punch and be sure center bolt is sufficiently lubricated. Note the Red Alignment Marks – They must be in up position and aligned at all times.

**CAUTION: DO NOT LOOSEN, CONTINUE TIGHTENING UNTIL TOOL BECOMES FREE IN DASH. TWO CLICKS SHOULD BE HEARD.**
  - F. Remove complete tool by pushing through cut hole in dash.
6. Note terminal numbers on Lucas switch (see illustration E). Gaining access through speedometer opening, slip retainer clip on the three headlight wires, then pass wires through opening for switch. Connect wire 1 thru 3 to the corresponding terminals.
7. Insert switch into dash, hold switch in position and through speedometer opening secure retainer clip to switch (see illustration D).
8. Connect battery ground terminal and test lights. Position 1 (first click), parking lights – position 2 (second click), headlights. After test, remove battery ground terminal.
9. Install speedometer.
10. Connect battery ground terminal.
